# Manhole Inspection Summary

Manhole # S25C1\_011MH

Insp Date: **4/11/08 2:28 PM**

**Location** Address: **2627 MAISEL ST.**

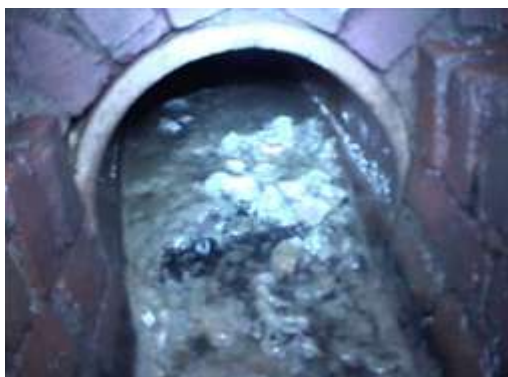
Defect 4

Condition: ☐ Sound ☐ Cracked ☐ Root Intrusion ☐ Deteriorated ☐ Leaks ☒ **Debris**

channel debris

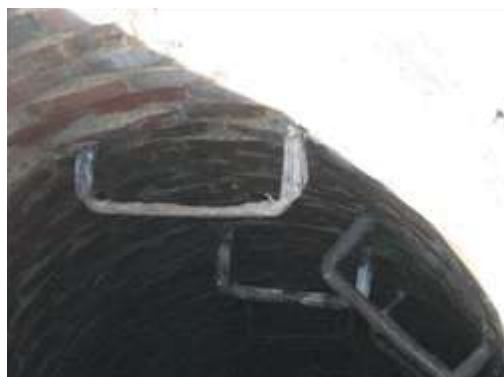
Defect 3

Count: **7** Missing: **0** ☒ **Corroded**

CORRODED STEPS

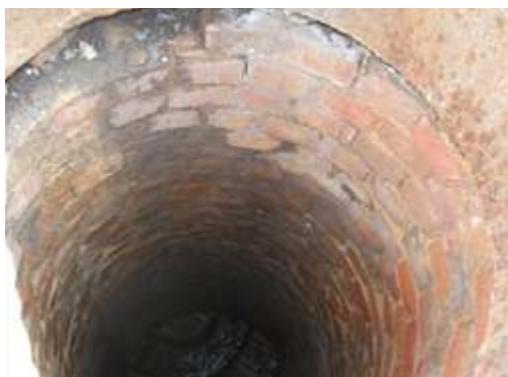
Defect 1

Condition: ☐ Sound ☐ Cracked ☐ Root Intrusion ☒ **Loose Brick** ☒ **Deteriorated**

Infiltration: ☐ None ☒ **Joint** ☐ Cracks ☐ Mortar ☐ Roots ☒ **Wall**

Loose Bricks and Deterioration in Chimney, Chimney Infiltration, Corbel Infiltration, Frame Offset

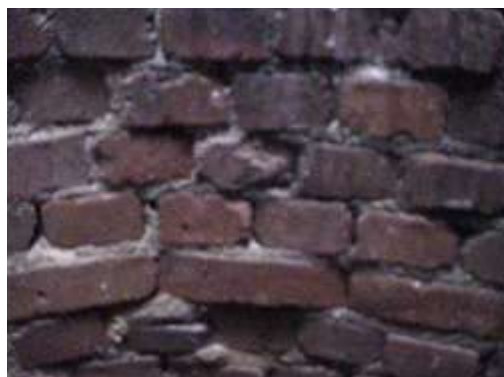
Defect 2

Condition: ☐ Sound ☐ Cracked ☐ Root Intrusion ☐ Loose Brick ☒ **Deteriorated**

Infiltration: ☐ None ☐ Joint ☐ Cracks ☐ Mortar ☐ Roots ☒ **Wall**

Evidence of Barrel Infiltration, Deteriorating Barrel

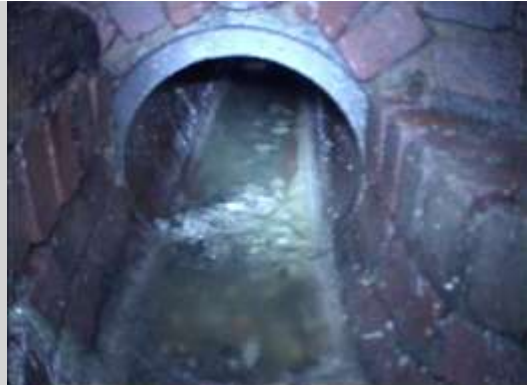
12 O'Clock Outflow

12 in. Circular Gravity Sewer  
Pipe Out @ 12 O'Clock

Pipe Height: **12** (in.) Rod and Bar (Angled)  
Pipe Material: **Clay** ☐ Pipe Lined  
Invert Depth: **13.90** (ft.) Flow Characteristics: **None**  
Deposits: ☒ None ☐ Mud ☐ Sludge ☐ Debris ☐ Grease  
Silt Depth: **0** (in.) Deposits Extent:  
Infiltration: **None** Pipe Seal Cond: **Sound**

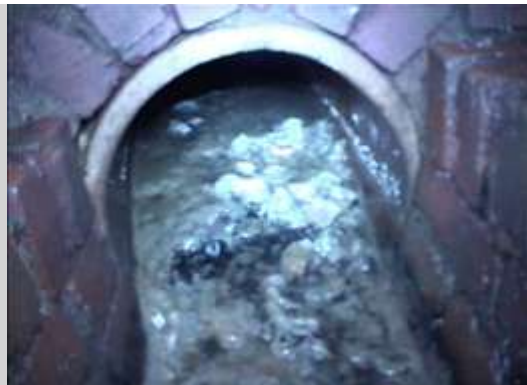
3 O'Clock Inflow

12 in. Circular Gravity Sewer  
Pipe In @ 3 O'Clock

Pipe Height: **12** (in.) Rod and Bar (Angled)  
Pipe Material: **Clay** ☐ Pipe Lined  
Invert Depth: **13.82** (ft.) Flow Characteristics: **None**  
Deposits: ☒ None ☐ Mud ☐ Sludge ☐ Debris ☐ Grease  
Silt Depth: **0** (in.) Deposits Extent:  
Infiltration: **None** Pipe Seal Cond: **Sound**

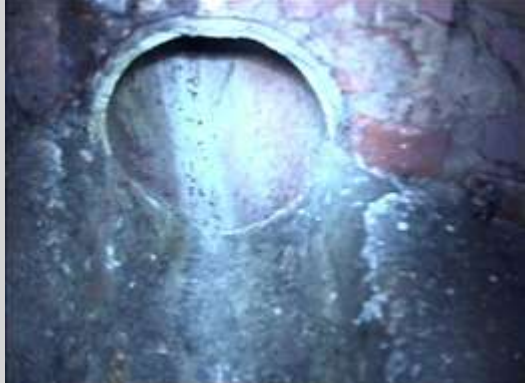
9 O'Clock Inflow

8 in. Circular Gravity Sewer

Pipe In @ 9 O'Clock

Pipe Height: **8.4** (in.) Rod and Bar (Angled)

Infiltration: **None** Pipe Seal Cond: **Sound**
